# Manhole Inspection Summary

Manhole # S43UU\_026MH

Insp Date: **2/12/07 8:52 AM**

**Location** Address: **2821 KENNEDY AVE**

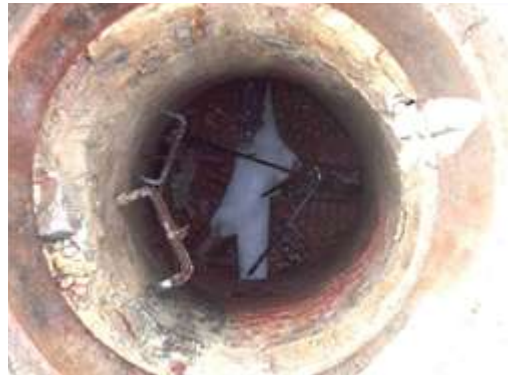
Top View

**Bench** ☒ Exists Material: **Brick** ☐ Parged ☒ **Debris** (not Condition related)

**Channel** Material: **Brick** ☐ Parged ☒ **Debris** (not Condition related)

**Surcharge** ☒ **Evidence Of Surcharge** Depth: **4** (ft.) ☐ Active Surcharge Present

Evidence of surcharge - Bench debris.  
Channel debris.

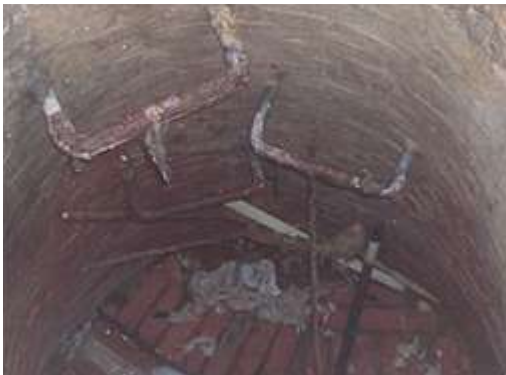
Defect

Infiltration: ☐ None ☐ Joint ☐ Cracks ☐ Mortar ☐ Roots ☒ **Wall**

Barrel infiltration.

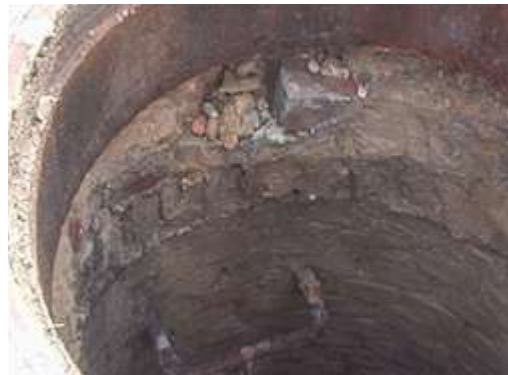
Defect

**Frame** Offset: **3** (in.) Condition: ☐ Sound ☐ Cracked ☒ **Leaks**

Condition: ☐ Sound ☐ Cracked ☐ Root Intrusion ☐ Loose Brick ☒ **Deteriorated**

Infiltration: ☐ None ☒ **Joint** ☐ Cracks ☐ Mortar ☐ Roots ☒ **Wall**

Frame leaks. Frame offset. Adjustment  
deterioration and infiltration.

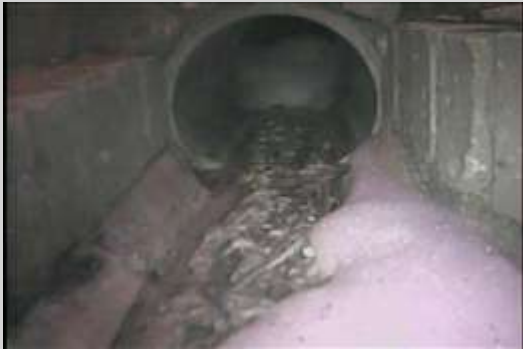
### 8 in. Circular Gravity Sewer Pipe Out @ 12 O'Clock

Deposits: ☐ None ☒ **Mud** ☐ Sludge ☒ **Debris** ☐ Grease

Silt Depth: **0.5** (in.) Deposits Extent: **Light**

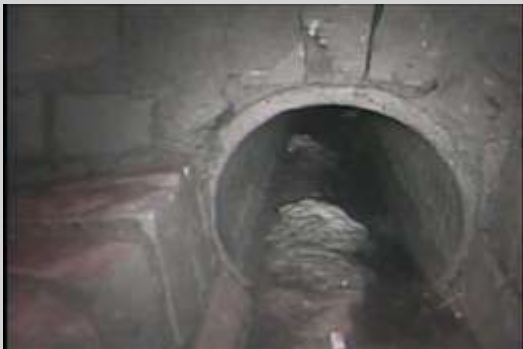
### 8 in. Circular Gravity Sewer Pipe In @ 3 O'Clock

Deposits: ☐ None ☒ **Mud** ☐ Sludge ☒ **Debris** ☐ Grease

Silt Depth: **0.5** (in.) Deposits Extent: **Light**

Infiltration: **Evidence** Pipe Seal Cond: **Unknown**

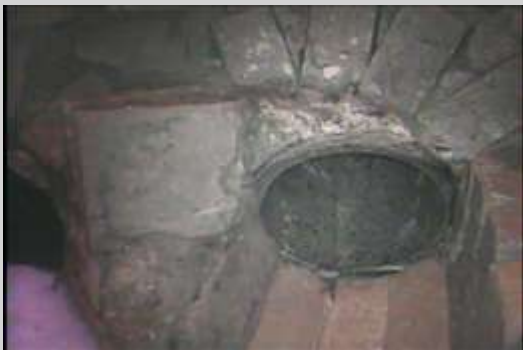
Pipe In @ 7 O'Clock

Infiltration: **Evidence** Pipe Seal Cond: **Unknown**
